Thermography Inspection at

**New Hanover County Courthouse
316 Princess Street
Wilmington, NC 28402
5th Floor Mechanical Room**

7/16/08

**Thermography Inspection
at
New Hanover County Courthouse**

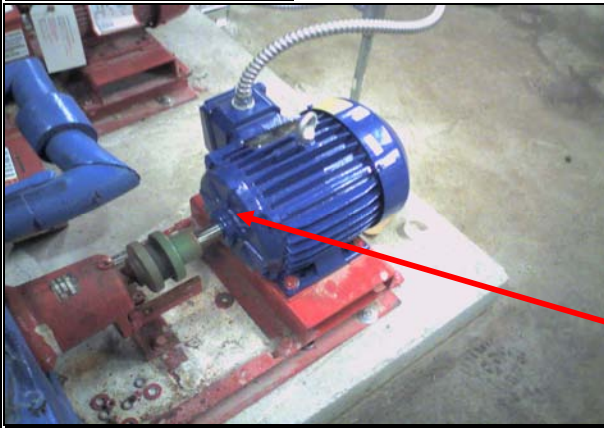
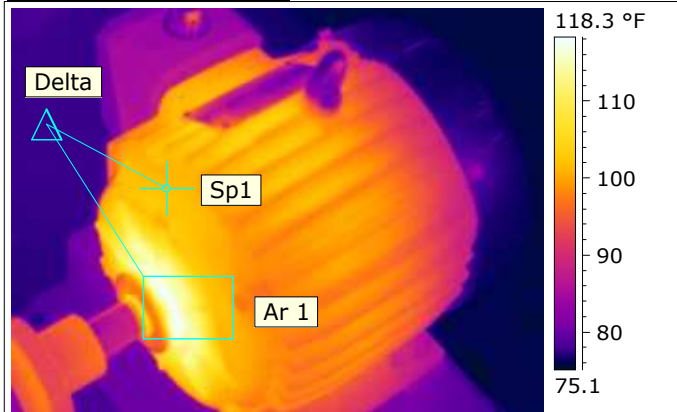
Location	5th Floor Mechanical Room
Equipment	Chilled Water Pump
Fault	(1)
Recommendation	Monitor

"Hot Spot"/Possible Anomaly

Image Date	7/16/2008
Image Time	9:25:46 AM
Emissivity	0.95
Object Distance	10.0 ft
Relative Humidity	57.0 %
Atmospheric Temperature	74.3 °F
Reflected Temperature	73.8 °F
Ar 1 Max. Temperature	118.3 °F
Sp1 Temperature	101.8 °F
Delta Value	16.5

We were informed that this was a fairly recently replaced pump. The uniform gradient thermal pattern in this motor housing suggests normal operation. The Delta Value is derived from the temperature rise between the high temp inside the Area 1 box and the average temp of the motor housing identified by the Spot 1. The only possible cause for concern is the Delta value of 16.5° F in the area where a bearing is located. Although this is not critical at this time, it may be necessary to monitor this bearing and inspect it during normal shutdown and /or scheduled maintenance.

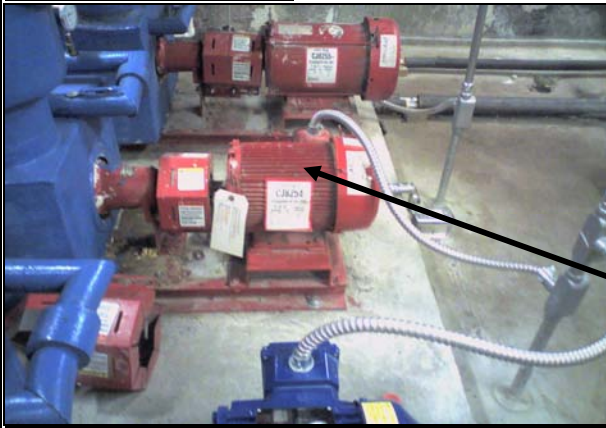
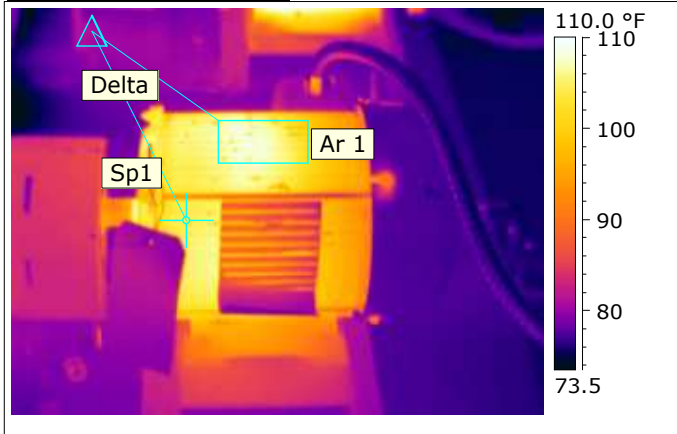
Location	5th Floor Mechanical Room
Equipment	Chilled Water Pump
Fault	(0)
Recommendation	None Required

Identifies hottest area of the motor housing

Image Date	7/16/2008
Image Time	9:25:24 AM
Image Description	-
Emissivity	0.95
Object Distance	10.0 ft
Reflected Temperature	73.8 °F
Relative Humidity	57.0 %
Ar 1 Max. Temperature	108.5 °F
Sp1 Temperature	103.8 °F
Delta Value	4.7

This motor appears to be operating in a normal fashion under normal temperatures. Note that there is only a 4.7° F rise in temperature in the average surface area and the hottest surface area.

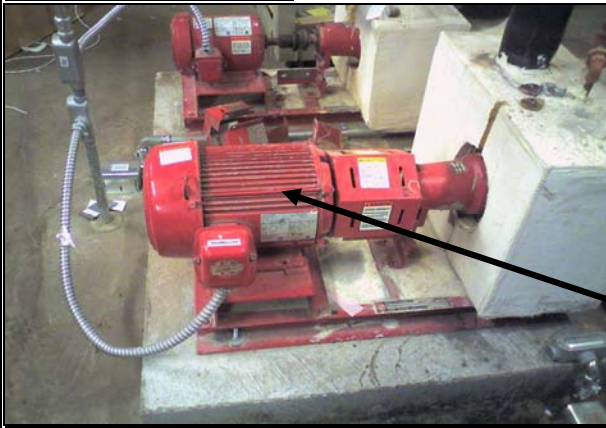
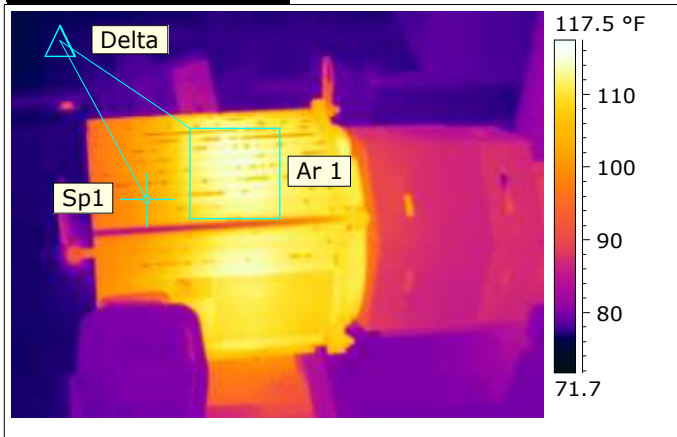
Location	5th Floor Mechanical Room
Equipment	Hot Water Pump
Fault	(1)
Recommendation	Monitor

Hot Spot in Motor Housing

Image Date	7/16/2008
Image Time	9:26:08 AM
Image Description	-
Emissivity	0.95
Object Distance	10.0 ft
Reflected Temperature	73.8 °F
Relative Humidity	57.0 %
Ar 1 Max. Temperature	115.0 °F
Sp1 Temperature	102.4 °F
Delta Value	12.6

Although the overall temperature of this motor housing is not alarming; the Delta temp in the casing is high enough to merit monitoring. There is a possibility of winding wear that could eventually cause a failure. Our recommendation is to schedule a future Thermal Scan to better monitor the integrity of this particular pump.

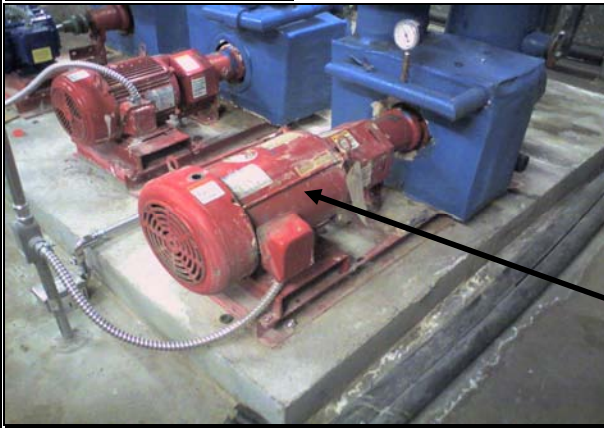
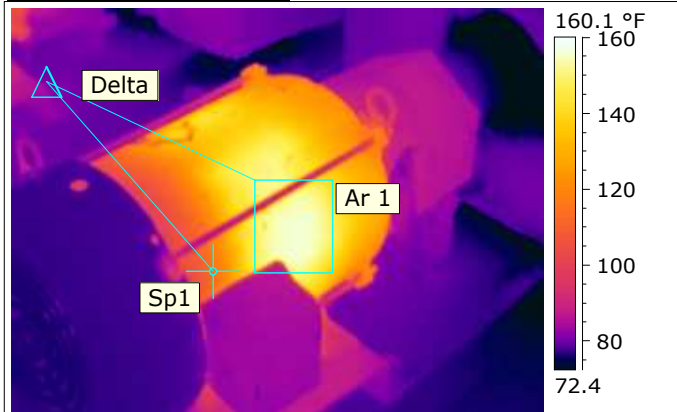
Location	5th Floor Mechanical Room
Equipment	Chilled Water Pump
Fault	(2)
Recommendation	Schedule Repair

Severe Hot Spot in Motor Housing

Image Date	7/16/2008
Image Time	9:40:49 AM
Image Description	-
Emissivity	0.95
Object Distance	10.0 ft
Reflected Temperature	73.8 °F
Relative Humidity	57.0 %
Ar 1 Max. Temperature	155.8 °F
Sp1 Temperature	114.3 °F
Delta Value	41.6

This motor housing shows potentially severe wear in the windings of this component. The Delta temp of 41.6 degrees in this housing identifies a high potential for failure. It is significant enough to immediately inspect and schedule a repair for this unit.

**Note that the Max temp for this particular pump is 47°F higher than the adjacent pump.*

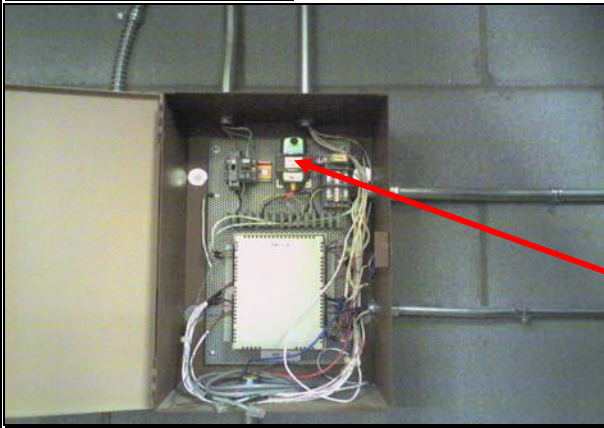
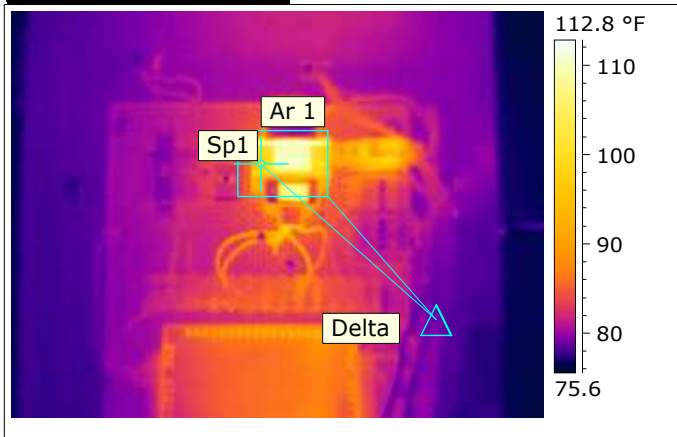
Location	5th Floor Mechanical Room
Equipment	Transformer
Fault	(?)
Recommendation	Contact Manufacturer

Possible Overloaded Transformer

Image Date	7/16/2008
Image Time	9:39:55 AM
Image Description	-
Emissivity	0.85
Object Distance	10.0 ft
Reflected Temperature	73.8 °F
Relative Humidity	57.0 %
Ar 1 Max. Temperature	112.9 °F
Sp1 Temperature	97.1 °F
Delta Value	15.8

This transformer *appears* to be functioning properly. The manufacturer if this transformer needs to be contacted to determine what the normal operating load should be for this particular component. Some loads and temperatures of this type are completely normal if the component is rated for such a load. Only the manufacturer will be able to satisfy this information. Even though this seems to be a normal operating temp, we can compare the current temperature information to future scan results to create temperature trending and more accurately identify potential failures.

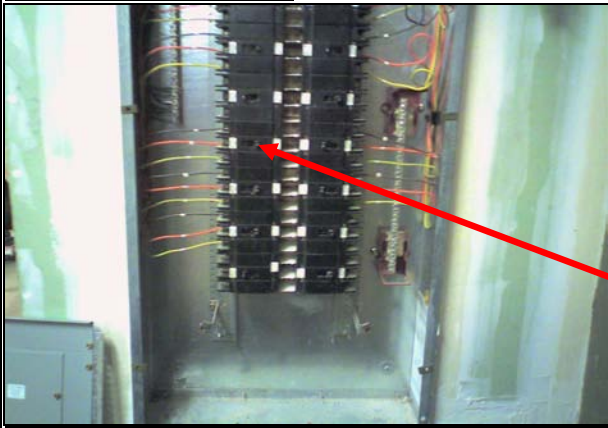
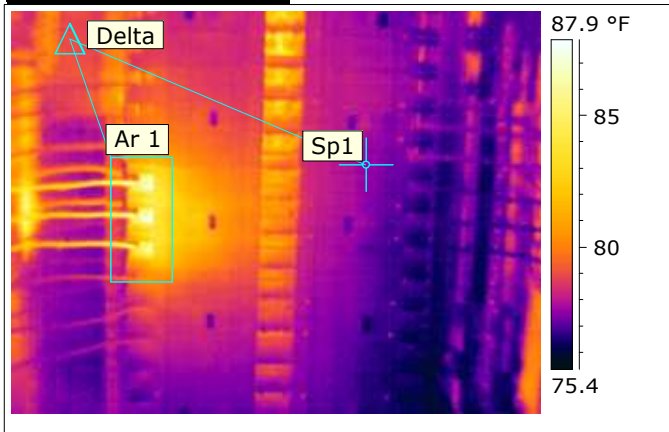
Location	5th Floor Mechanical Room
Equipment	Electrical Panel
Fault	(0)
Recommendation	None Required

Circuit Break shows normal loading

Image Date	7/16/2008
Image Time	9:36:23 AM
Image Description	-
Emissivity	0.95
Object Distance	10.0 ft
Reflected Temperature	73.8 °F
Relative Humidity	57.0 %
Ar 1 Max. Temperature	87.9 °F
Sp1 Temperature	77.5 °F
Delta Value	10.4

Electrical Panel exhibits normal load distribution and connectivity. Temperature rises of this nature under normal conditions are typical.

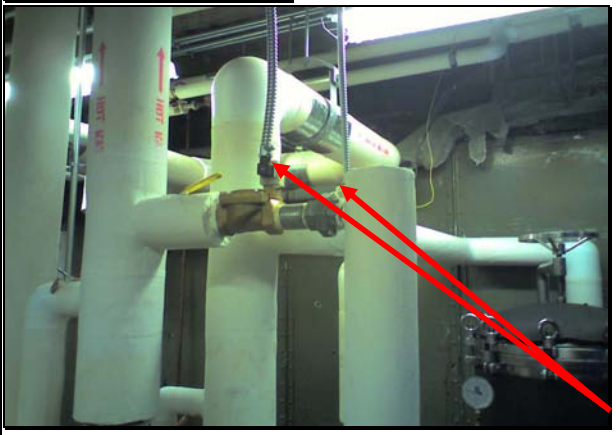
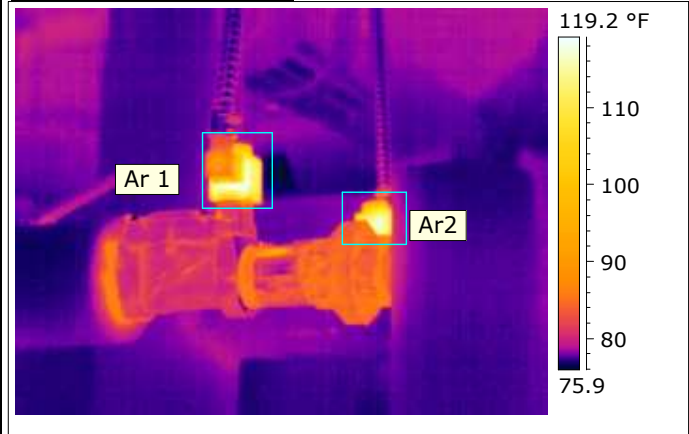
Location	5th Floor Mechanical Room
Equipment	Hot Water Valve
Fault	(0)
Recommendation	None

Image Date	7/16/2008
Image Time	9:33:15 AM
Image Description	-
Emissivity	0.95
Object Distance	10.0 ft
Reflected Temperature	73.8 °F
Relative Humidity	57.0 %
Ar 1 Max. Temperature	119.1 °F
Ar 2 Max. Temperature	117.9 °F

Area boxes show average temperatures for these hot water valves. They appear to be functioning properly.

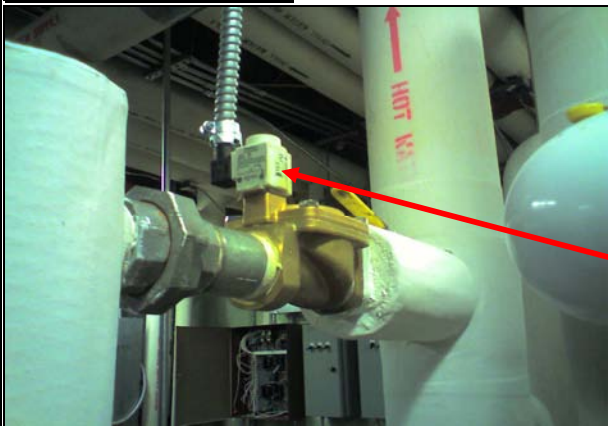
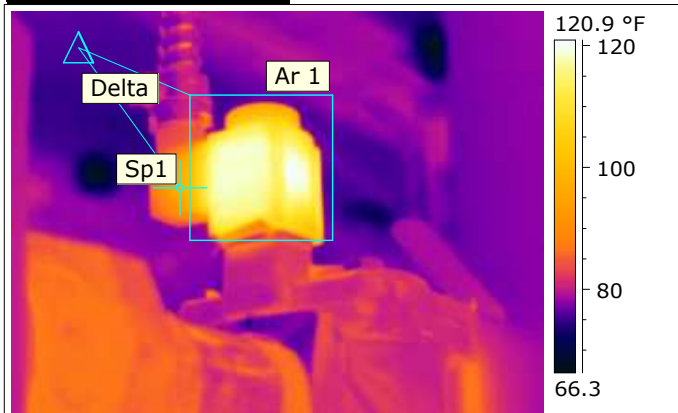
Location	5th Floor Mechanical
Equipment	Hot Water Valve?
Fault	(1)
Recommendation	Monitor

Possible compromised water valve

Image Date	7/16/2008
Image Time	9:33:38 AM
Image Description	-
Emissivity	0.95
Object Distance	10.0 ft
Reflected Temperature	73.8 °F
Relative Humidity	57.0 %
Atmospheric Temperature	74.3 °F
Ar 1 Max. Temperature	120.8 °F
Sp1 Temperature	97.4 °F
Delta Value	23.4

This water valve appears to be operating a bit warmer than expected. We recommend scheduling a future Thermal Scan to monitor temperature and avoid a potential failure.

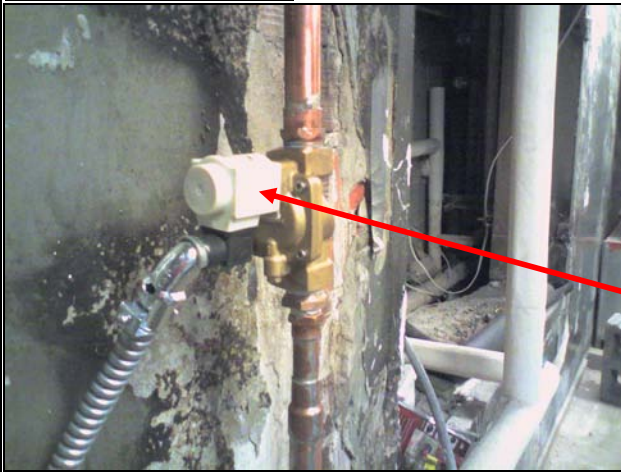
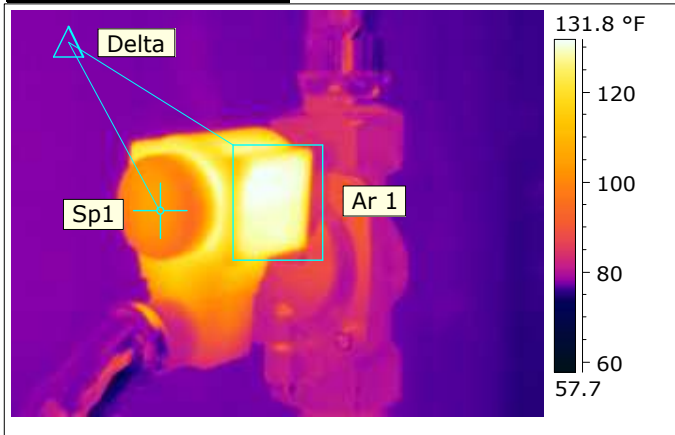
Location	5th Floor Mechanical Room
Equipment	Hot Water Valve
Fault	(1)
Recommendation	Monitor

Hot Spot in Valve

Image Date	7/16/2008
Image Time	9:41:45 AM
Image Description	-
Emissivity	0.95
Object Distance	10.0 ft
Reflected Temperature	74.8 °F
Relative Humidity	57.0 %
Atmospheric Temperature	74.3 °F
Ar 1 Max. Temperature	131.6 °F
Sp1 Temperature	104.1 °F
Delta Value	27.5

Overall temp is 11.6° F hotter than the average of the other valves. Again we recommend monitoring this valve to see if its operating max temperature is within the expected range.

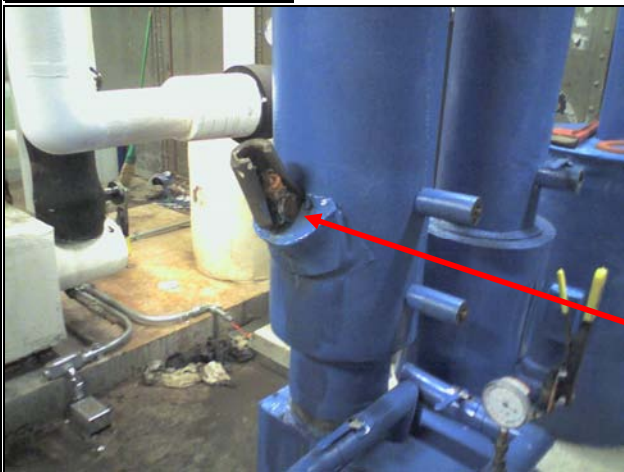
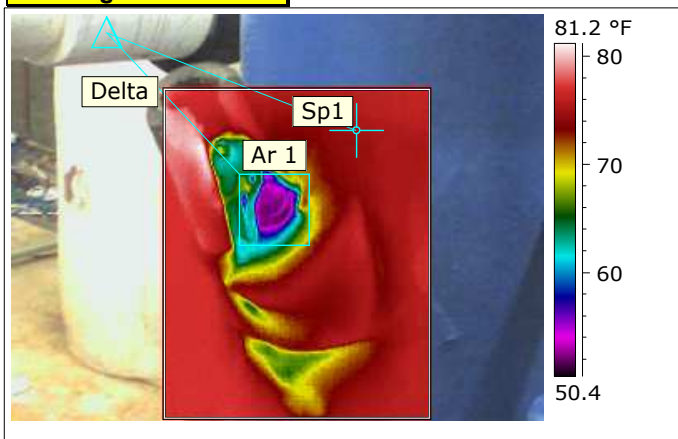
Location	5th Floor Mechanical Room
Equipment	Chilled Water Line Valve
Fault	(2)
Recommendation	Repair Immediately

Defective Water Valve

Image Date	7/16/2008
Image Time	9:43:50 AM
Image Description	-
Emissivity	0.90
Object Distance	10.0 ft
Reflected Temperature	73.8 °F
Relative Humidity	57.0 %
Sp1 Temperature	75.1 °F
Delta Value	-23.8
Ar 1 Min. Temperature	51.2 °F

This is the first valve in a line of three. Behind the foam insulation there was a visible water leak in this valve. The thermal image shows a Delta value of -23.8. This leak will eventually destroy the pipe insulation if not repaired. This is an active leak and needs immediate attention.

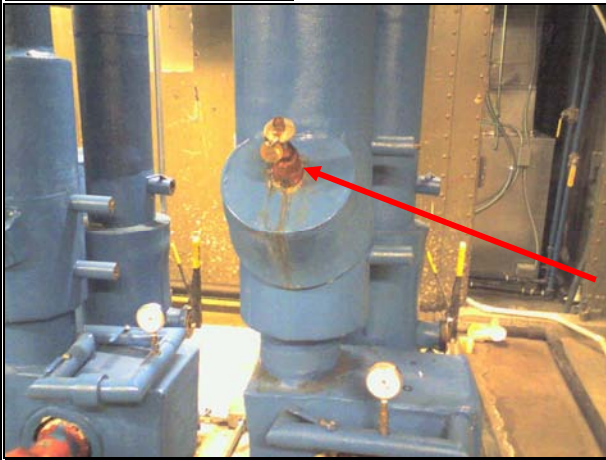
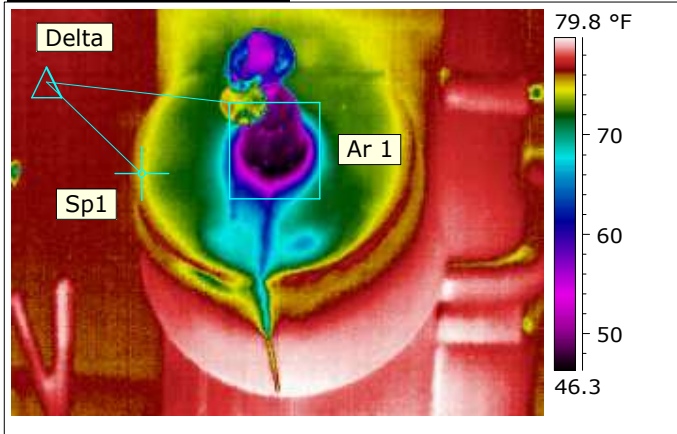
Location	5th Floor Mechanical Room
Equipment	Water Valve
Fault	(2)
Recommendation	Repair Immediately

Defective Water Valve

Image Date	7/16/2008
Image Time	9:44:18 AM
Image Description	-
Emissivity	0.90
Object Distance	10.0 ft
Reflected Temperature	73.8 °F
Relative Humidity	57.0 %
Sp1 Temperature	74.8 °F
Delta Value	-28.5
Ar 1 Min. Temperature	46.3 °F

This is #3 in a line of three valves for the Chilled water lines; each one has its own leak. This particular valve is the most critical. Note the stream of water coming from the connection point of the valve. This is an active leak and is critical need of replacement. Once again the insulation will be destroyed if not repaired.

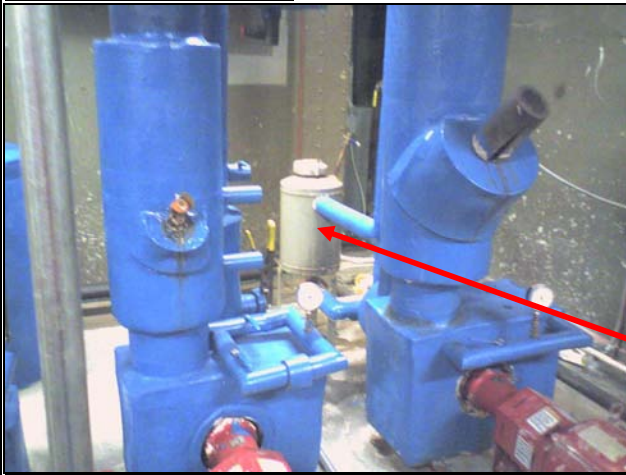
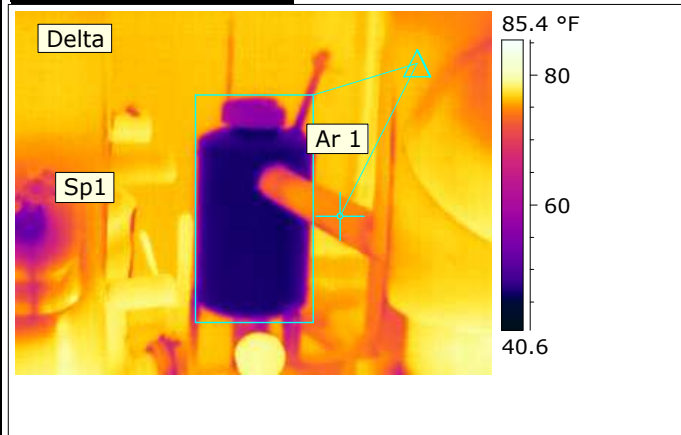
Location	5th Floor Mechanical Room
Equipment	Chilled Water Tank
Fault	(2)
Recommendation	Insulate

Chilled Water Holding Tank

Image Date	7/16/2008
Image Time	9:27:56 AM
Image Description	-
Emissivity	0.95
Object Distance	10.0 ft
Reflected Temperature	73.8 °F
Relative Humidity	57.0 %
Sp1 Temperature	74.5 °F
Delta Value	-28.7
Ar 1 Min. Temperature	45.8 °F

This Chilled Water Tank has a surface temp of 45.8°F and is almost 29°F colder than the insulation around the chilled water lines. We recommend insulating the outside of the tank to increase the tank's efficiency.
